NAPIER WASTEWATER TREATMENT PLANT

Performance Evaluation

Napier City Council holds a consent for the discharge of treated wastewater from the Napier Wastewater Treatment Plant (WWTP) at Awatoto via an ocean outfall to Hawke Bay.

It also requires a performance evaluation report to be prepared every three years, which includes a summary of the monitoring results, any non-compliance with consent conditions, an evaluation of any trends and provides an opportunity for public response. This report has been prepared to meet that consent condition, for the period 1 July 2020 to 30 June 2024.

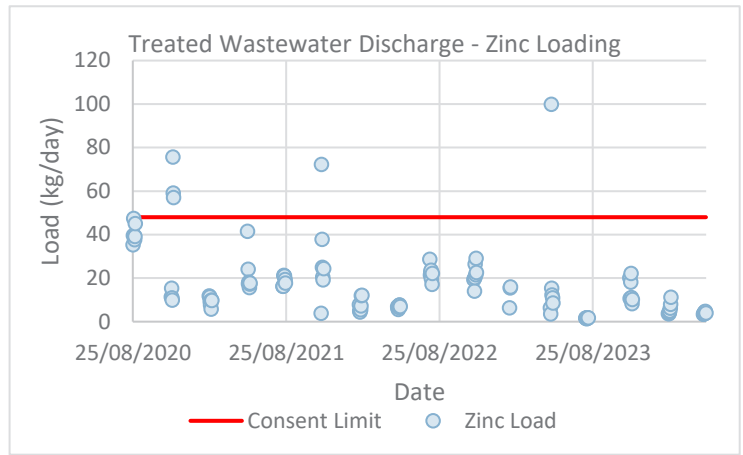
Figure 1: Treated wastewater discharge - zinc loading

All contaminants except zinc were consistently below the consent limits. There were five times when the consent limit for zinc was exceeded (Figure 1). It's not clear why zinc was sometimes above the limit.

- The metal and ammonia loads in the treated wastewater were all within the consent limits, apart from zinc which had five instances of high zinc loading.

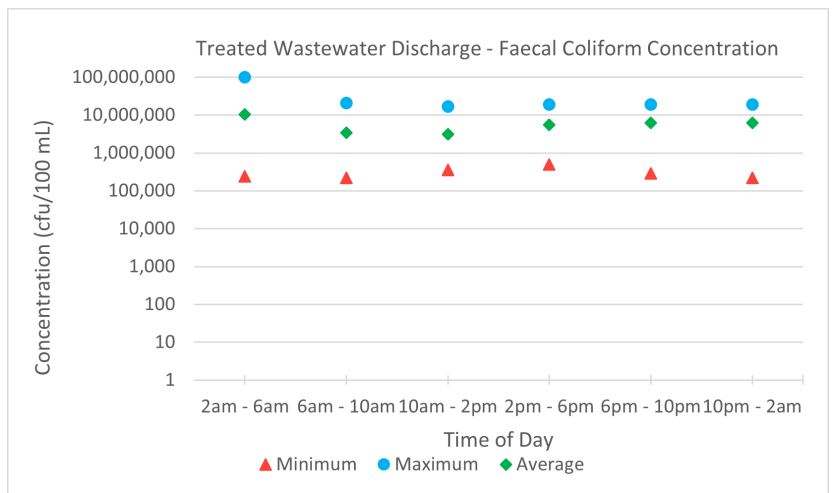
Figure 6: Faecal coliforms concentrations in treated wastewater

Figure 6 and Figure 7 show the average, maximum and minimum concentration throughout the day. There is no clear difference in concentration at various times of the day.

The concentration of faecal coliforms and Enterococci (indicators of pathogens) in the treated wastewater is consistent throughout the day.

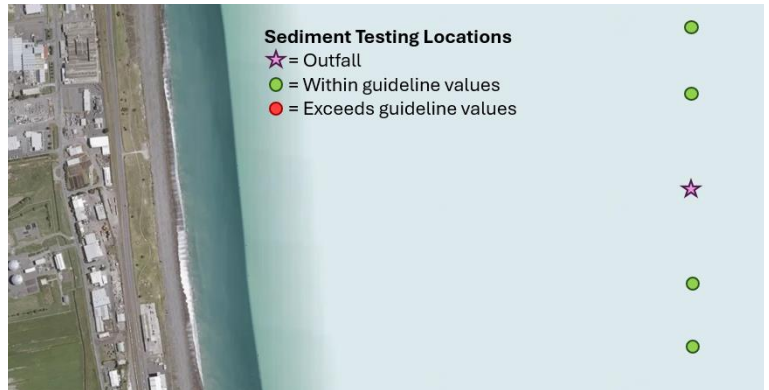
Figure 8: Sediment Testing

Twice a year seabed sediment samples are collected 300 m and 500 m north and south of the outfall diffuser. The samples are analysed for arsenic, cadmium, chromium, copper, mercury, nickel, lead, selenium and zinc. As metals accumulate in sediment, this provides a good measure of the effect of the discharge over time. The results are summarised in Figure 8. All results were within the guideline values for sediment quality (ANZECC & ARMCANZ, 2000).

Sediment quality near the outfall was consistently within the guideline values. Biodiversity south of the outfall was lower than in other areas near the outfall, and this has declined over time, suggesting some negative impacts from the discharge.

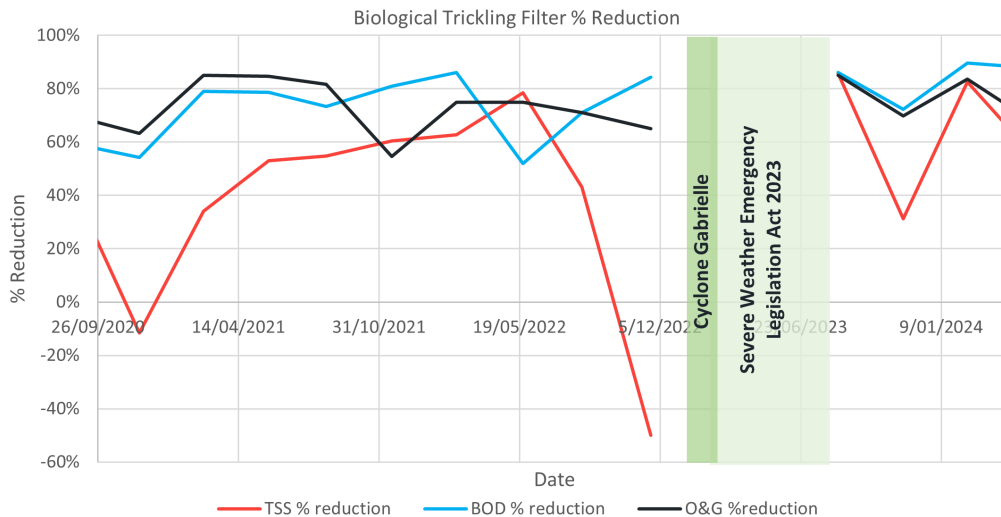
Figure 10: Biological Trickling Filter Performance

The performance of the biological trickling filter was fairly consistent in reducing biochemical oxygen demand and oil and grease. Its performance was more variable for reducing total suspended solids, with an increase in suspended solids through the biological trickling filter in November 2022. This may have been an anomaly as the bi-weekly data taken at the same time showed a reduction by 32%.

The performance of the biological trickling filter is measured every three months. It is measured by taking a 24-hour flow proportional sample of wastewater before and after the biological trickling filters. The average percentage reduction is shown in Figure 10.
